This report serves as the Phase II milestone 9 deliverable under XXXXXXXXXXXXXXXXXXXXXXXX. Its purpose is to evaluate the results of a multi-laboratory round robin exercise, compare lab performance, and assess the effectiveness of standardized methods in detecting counterfeit-related defects.

3.1.3. IS41LV16256B-35TL

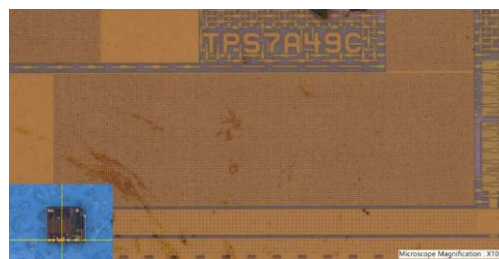
[TPS7A4901DGNT] Improper or Missing Die Markings – Refer to the above discussion for Wrong Die or Functional Passive Element for details on die markings. An example of the device’s die markings are shown in Figure 19 TPS7A4901DGNT Die Markings below.

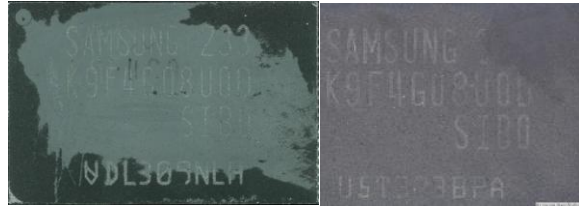
Figure 29 Resurfacing Comparison of Large vs. Small Processed Area

There is significant inconsistency in the methodology used to perform these tests which had an adverse impact on the test outcome. AS6171/2A is vague on the execution of these tests stating that a cotton swab is to be used to wipe the surface to determine if a coating can be removed. The process does not state how aggressive the surface should be wiped or how to distinguish between a positive or negative result (breakdown of encapsulant vs. coating removal). The process just states that “Any removed coating will show on the cotton swab as black in color”. This statement led some labs to interpret any discoloration on the swab indicated the presence of a coating without examination of the surface itself to determine if a coating had been present. Further, the process states to avoid part markings when possible. This guidance limits the usefulness of the test methods since it will likely miss the presence of ghost markings on a part. As an example of this, the images in Figure 29 below compare the top surface of the K9F4G08U0D-SIB0 where a larger portion of the surface was processed versus a small area. The ghost markings clearly visible on the large processed area were not detected when only a small area was processed. Only Lab 6 identified these ghost markings through the resurfacing test because of their methodology.

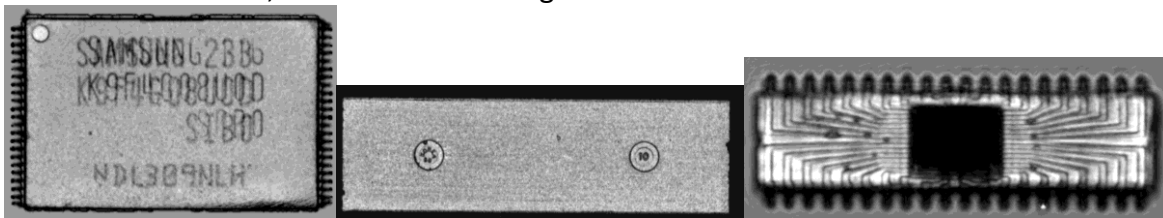
Figure 30 Example Lab 1 Surface Scans Showing Ghost Marking and Sanding, Thru Scan Showing Internal Features

Lab 1 and Lab 3 are the only two participating labs with the capability to perform Acoustic Microscopy. However, the approaches each lab utilize resulted in significantly differing results. Lab 1 performed reflection scans to image the surface interfaces and thru scans to evaluate internal construction on devices with thicker packages. The surface scans proved to be highly effective at the identification of defects such as ghost markings, top vs bottom surface inconsistencies, and sanding marks. Thru scans provided insight into the internal construction attributes very similar to those obtained through X-Ray providing imagery of attributes such as die size and orientation, and lead frame design.

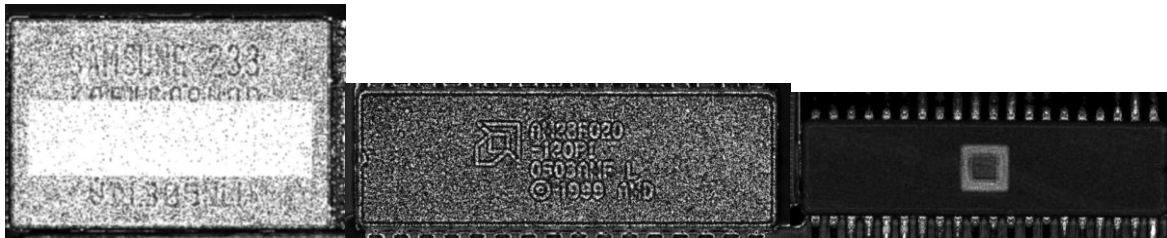
Figure 31 Example Lab 3 Scans of the Same Part views as Shown in Figure 30

The Lab 3 approach was focused more on the die interfaces which was effective at identifying delaminations on the IS41LV16256B-35TL and XCS30-3TQ144C which were not identified by the Lab 1 approach. However, the use of a single 25MHz transducer for all scans limited the ability to image surface artifacts resulting in not identifying the ghost markings which were observable in 4 of 5 parts in the Lab 1 subplot, sanding marks, or detailed internal structures such as those shown in Figure 30.

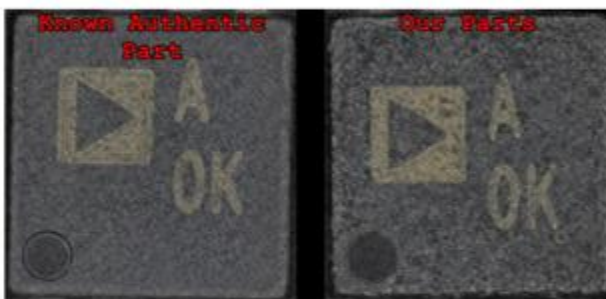
AD8616ARMZ-REEL in question due to etch inertness and surface morphology

Comparison of the top surface of our parts with a known authentic part. Note the rougher texture on our part.

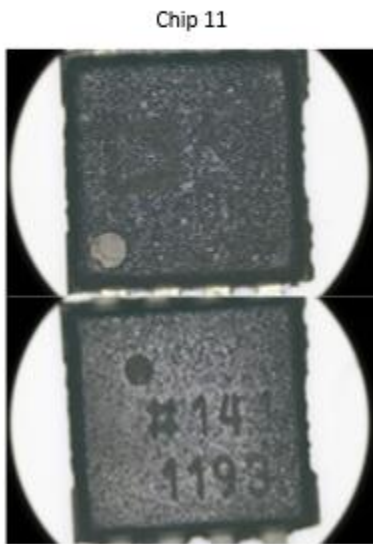
Chip 11

From our images and those sent by Steve W., the sample appears pitted to me.

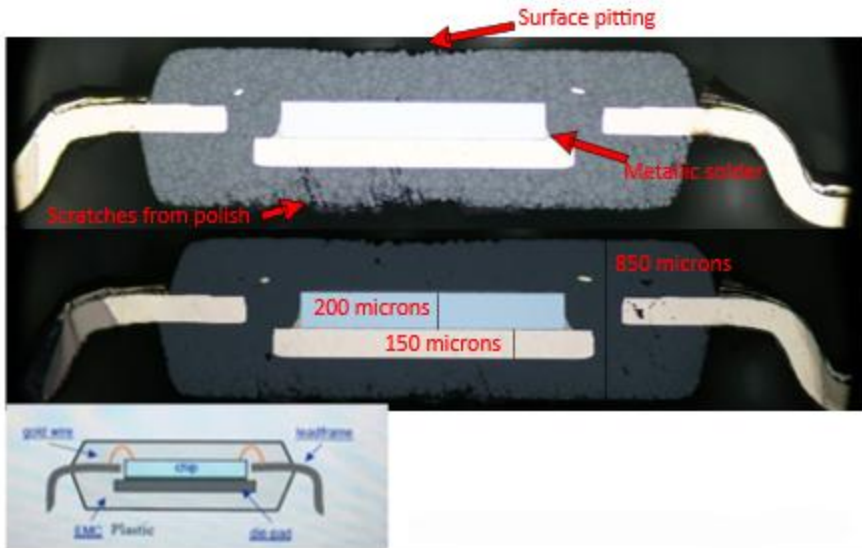
The composite that makes the encapsulant is homogeneous.

Eyeball average particle size ~ 50 microns

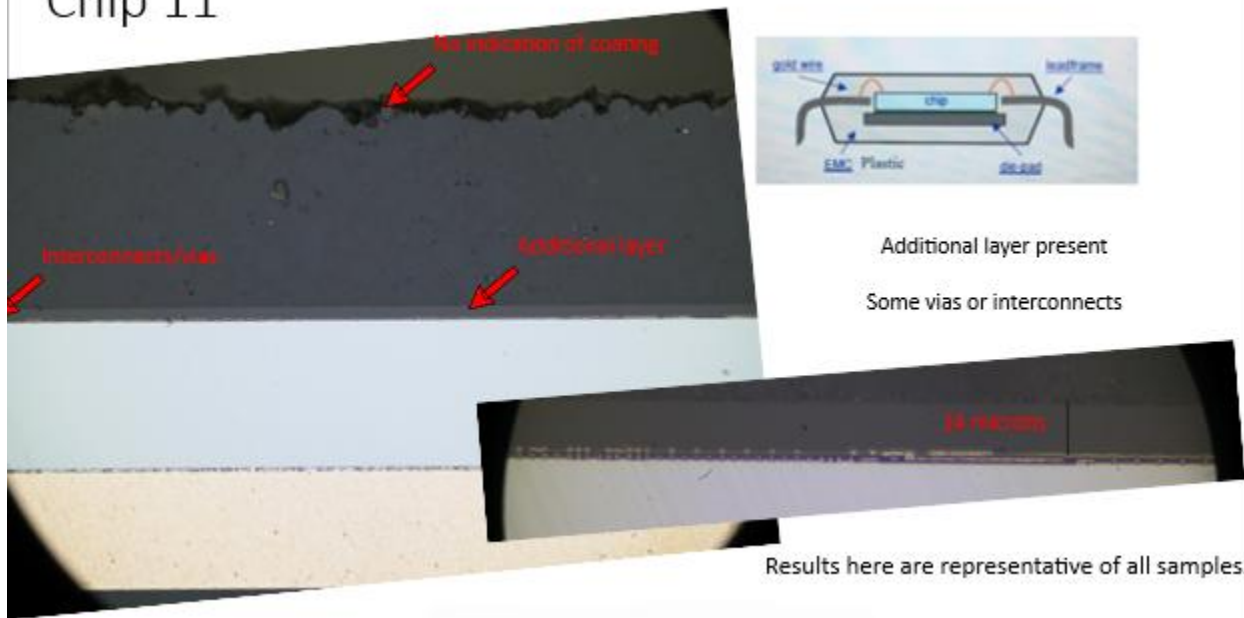
Chip 11

Additional layer present

Some vias or interconnects
