Lab Proficiency Assessment – Revision 2.2

This report serves as the Phase II milestone 9 deliverable under XXXXXXXXXXXXXXXXXXXX. Its purpose is to evaluate the results of a multi-laboratory round robin exercise, compare lab performance, and assess the effectiveness of standardized methods in detecting counterfeit-related defects.

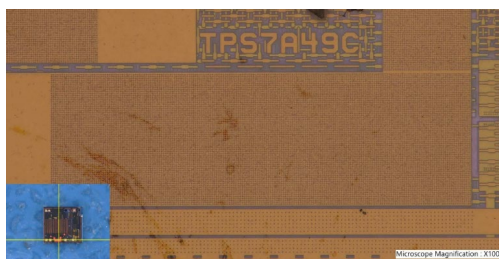
*Figure 19 TPS7A4901DGNT Die Markings*

[TPS7A4901DGNT] Improper or Missing Die Markings – Refer to the above discussion for Wrong Die or Functional Passive Element for details on die markings. An example of the device's die markings are shown in Figure 19 TPS7A4901DGNT Die Markings below.

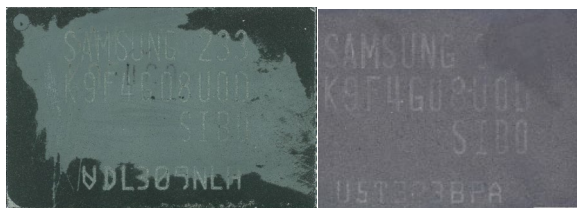
Figure 29 Resurfacing Comparison of Large vs. Small Processed Area

There is significant inconsistency in the methodology used to perform these tests which had an adverse impact on the test outcome. AS6171/2A is vague on the execution of these tests stating that a cotton swab is to be used to wipe the surface to determine if a coating can be removed. The process does not state how aggressive the surface should be wiped or how to distinguish between a positive or negative result (breakdown of encapsulant vs. coating removal). The process just states that “Any removed coating will show on the cotton swab as black in color”. This statement led some labs to interpret any discoloration on the swab indicated the presence of a coating without examination of the surface itself to determine if a coating had been present. Further, the process states to avoid part markings when possible. This guidance limits the usefulness of the test methods since it will likely miss the presence of ghost markings on a part. As an example of this, the images in Figure 29 below compare the top surface of the K9F4G08U0D-SIB0 where a larger portion of the surface was processed versus a small area. The ghost markings clearly visible on the large processed area were not detected when only a small area was processed. Only Lab 6 identified these ghost markings through the resurfacing test because of their methodology.

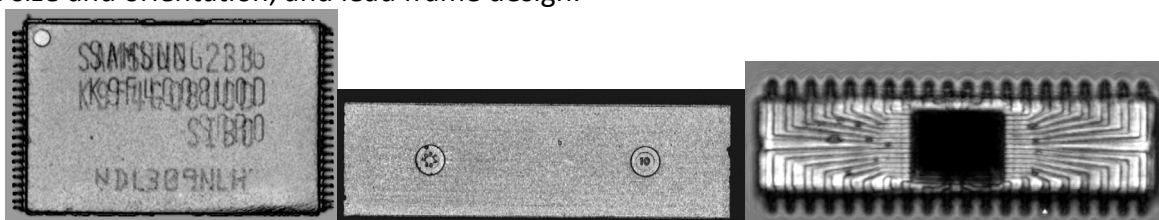
*Figure 30 Example Lab 1 Surface Scans Showing Ghost Marking and Sanding, Thru Scan Showing Internal Features*

Lab 1 and Lab 3 are the only two participating labs with the capability to perform Acoustic Microscopy. However, the approaches each lab utilize resulted in significantly differing results. Lab 1 performed reflection scans to image the surface interfaces and thru scans to evaluate internal construction on devices with thicker packages. The surface scans proved to be highly effective at the identification of defects such as ghost markings, top vs bottom surface inconsistencies, and sanding marks. Thru scans provided insight into the internal construction attributes very similar to those obtained through X-Ray providing imagery of attributes such as die size and orientation, and lead frame design.

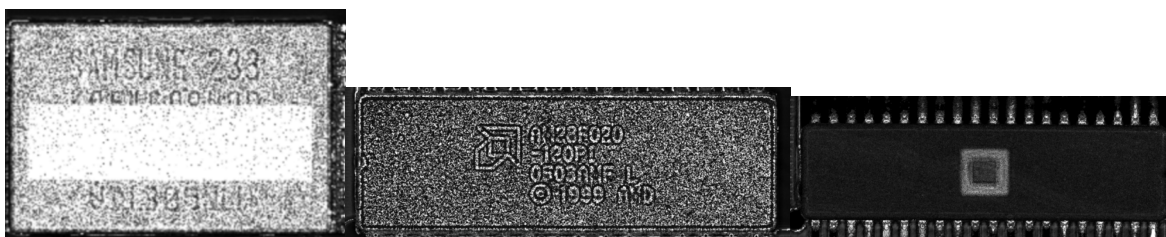
Figure 31 Example Lab 3 Scans of the Same Part views as Shown in Figure 30

The Lab 3 approach was focused more on the die interfaces which was effective at identifying delaminations on the IS41LV16256B-35TL and XCS30-3TQ144C which were not identified by the Lab 1 approach. However, the use of a single 25MHz transducer for all scans limited the ability to image surface artifacts resulting in not identifying the ghost markings which were observable in 4 of 5 parts in the Lab 1 subplot, sanding marks, or detailed internal structures such as those shown in Figure 30.

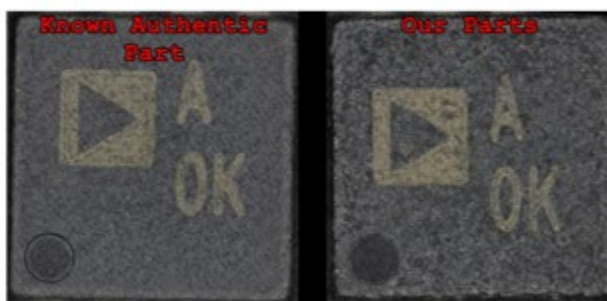
AD8616ARMZ-REEL in question due to etch inertness and surface morphology

Comparison of the top surface of our parts with a known authentic part. Note the rougher texture on our part.

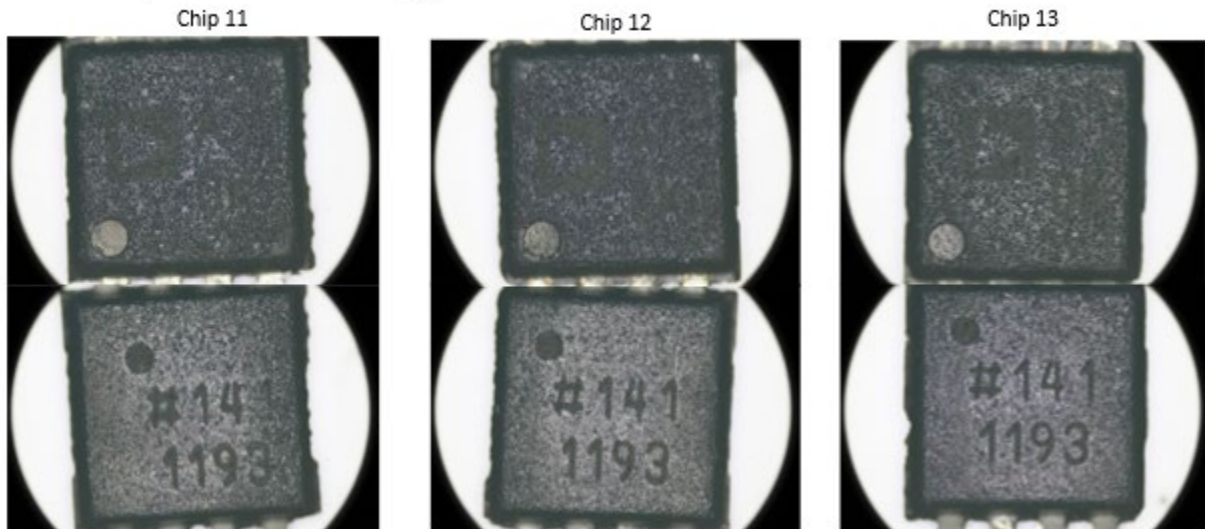
All samples appear qualitatively the same

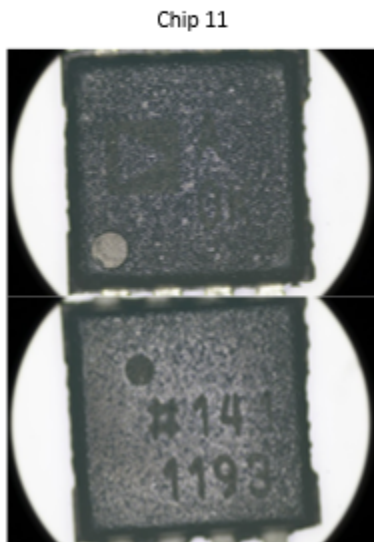
From our images and those sent by Steve W., the sample appears pitted to me.

Top surface is more pitted/textured than the bottom surface.

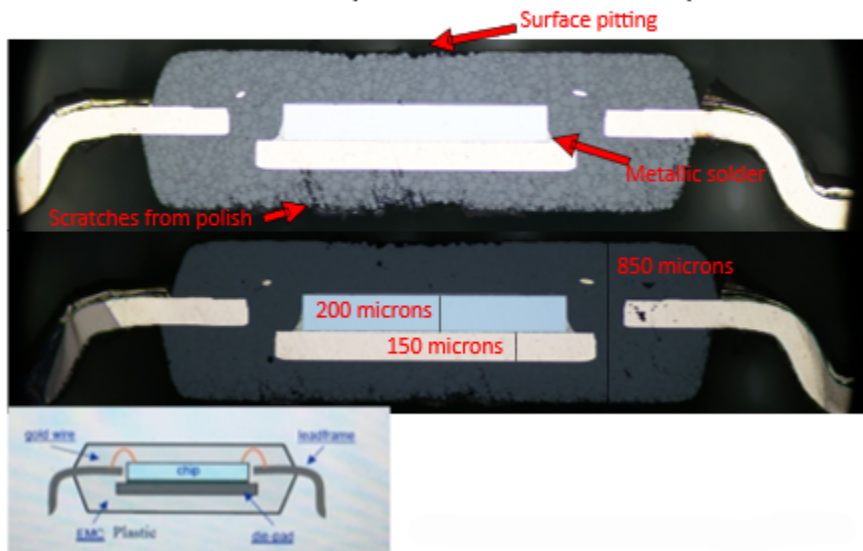
The composite that makes the encapsulant is homogeneous.

Eyeball average particle size ~ 50 microns

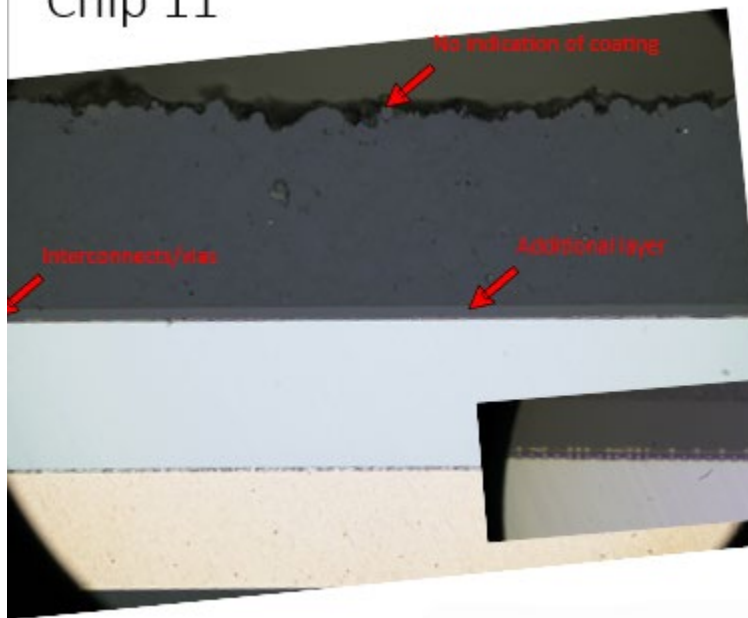
Additional layer present

Some vias or interconnects

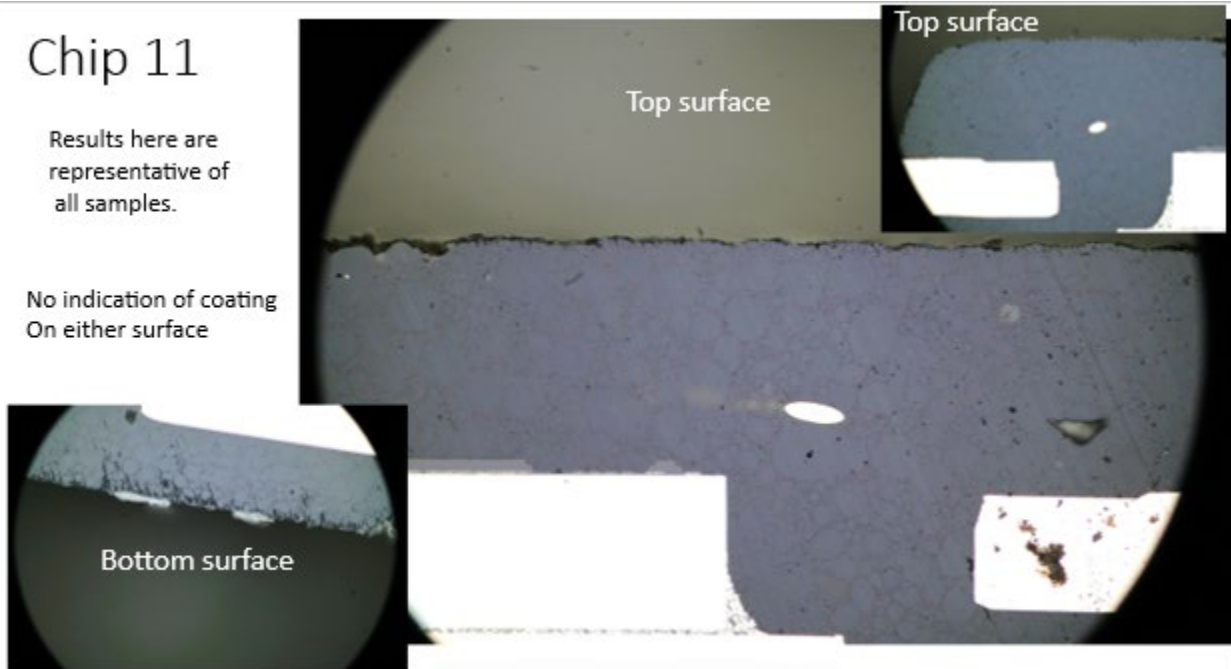
No indication of coating  
On either surface

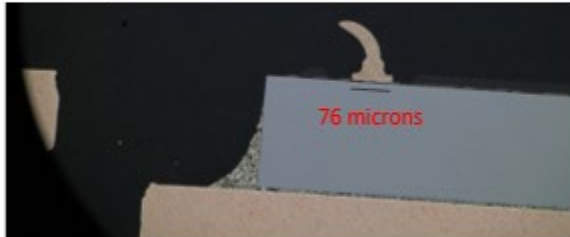
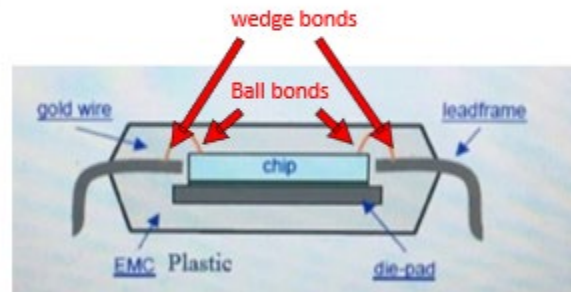
Chip 13

Was able to resolve the type of wire bonds.  
And approx. dimension of the ball bond
