This report serves as the Phase II milestone 9 deliverable under XXXXXXXXXXXXXXXXXXXXXXXX. Its purpose is to evaluate the results of a multi-laboratory round robin exercise, compare lab performance, and assess the effectiveness of standardized methods in detecting counterfeit-related defects.

3.1.3. IS41LV16256B-35TL

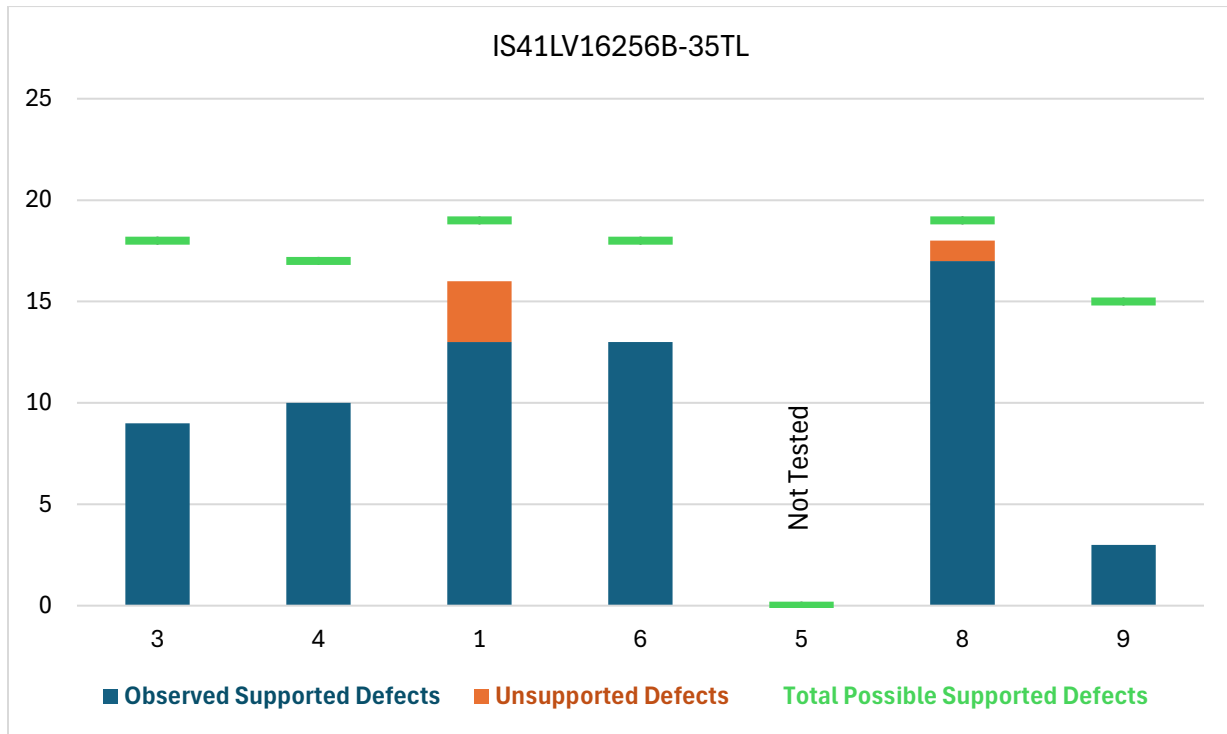
Figure 3 IS41LV16256B-35TL Defect Detection

All labs identified this part as suspect counterfeit. Table 5 summarizes the test methods and specific defects which had high correlation (>60%) between the test labs. Table 6 lists the defects identified by each lab and whether there was strong evidence presented to validate the presence of this defect (by any lab). Strong evidence was used as a criteria for establishing the Consensus Conclusion for each part. This evidence also

- Identification of whiskers on the leads was only noted by Lab 3, but photos of leads from several labs had multiple whiskers visible. Presence of this defect can be critical for reliable operation of hardware that parts may be used in.

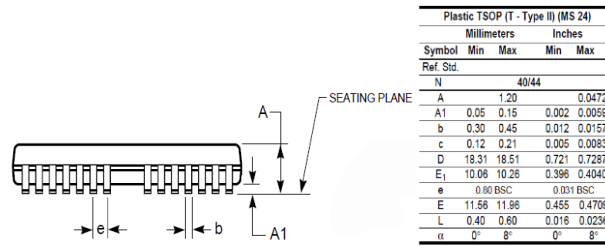
Figure 4 IS41LV16256B-35TL Dimensions

- Part dimension measurements were within specification for all labs except Lab 1. Lab 1 performed some measurements using calipers whereas all other labs utilized optical measurement techniques exclusively. AS6171/2 specifically requires the use of non-contact optical measurement tools for this test. This could account for some of the differences. Another contributor is the use of derived specifications. The manufacturer specifies the overall device height (A) as $A \leq 1.20\text{mm}$ (see Figure 4). The lead standoff height specified as dimension A1 is $0.05 < A1 < 0.15$. The package thickness is not a controlled parameter. Lab 1 derived a package thickness (T) from these values as $1.05 < T < 1.15$. As an example, device 1 measured $T = 1.00\text{mm}$ which is outside the derived limits. Standoff height (A1) and total height (A) were not measured. In comparison to

other labs which measured both (A) and (A1), no parts were outside either specification limit.

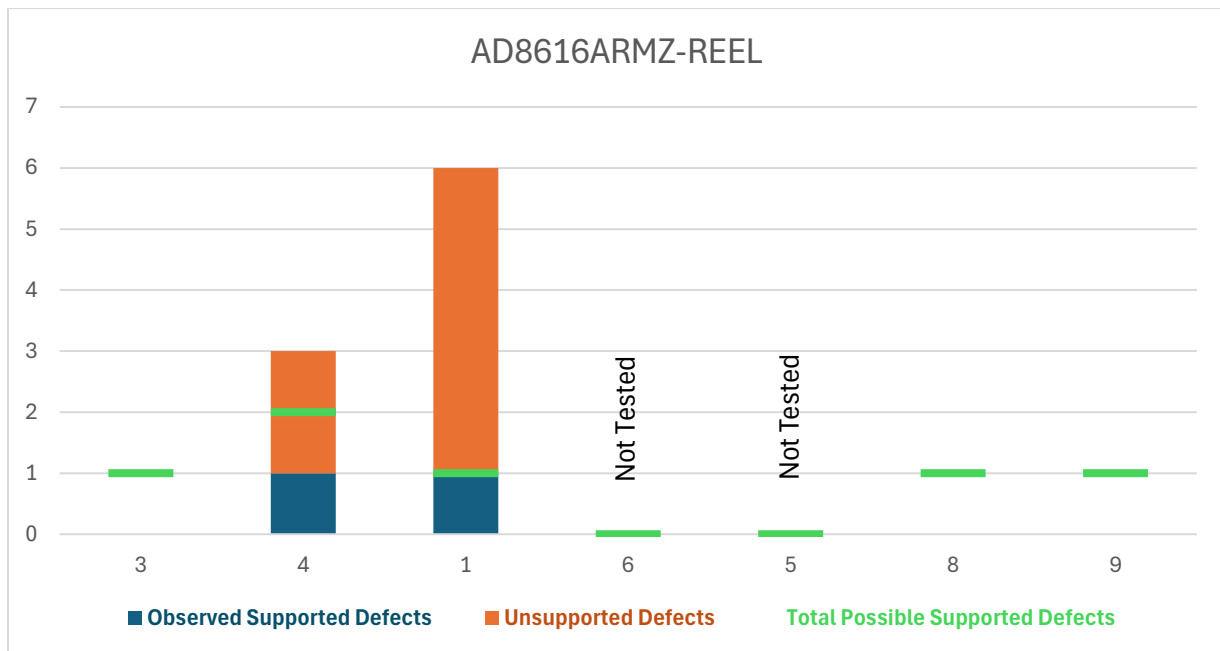
Figure 5 AD8616ARMZ-REEL Defect Detection

Labs were divided on whether this part was acceptable or suspect with 3 of 5 labs which tested the part declaring it acceptable. The primary area of discrepancy was the top surface finish which was unusually rough and appeared to have a coating on it when observed along the edge. Even though the part visually appeared to be coated, the parts passed resurfacing tests. To better understand the nature of this part’s finish, Aerocyonics requested the University of Michigan to perform a cross section analysis to inspect for potential coatings. A resurfaced part will show a clear change in the grain structure of the encapsulant at the material transition boundary if a coating is present. None was observed. See Appendix 1 for the University of Michigan analysis. Table 7 summarizes the test methods and specific defects which had high correlation (>60%) between the test labs. Table 8 lists the defects identified by each lab and whether there was strong evidence presented to validate the presence of this defect (by any lab). Strong evidence was used as a criteria for establishing the Consensus Conclusion for each part. This evidence also corresponds to defects which if present, should have been identifiable by test labs.

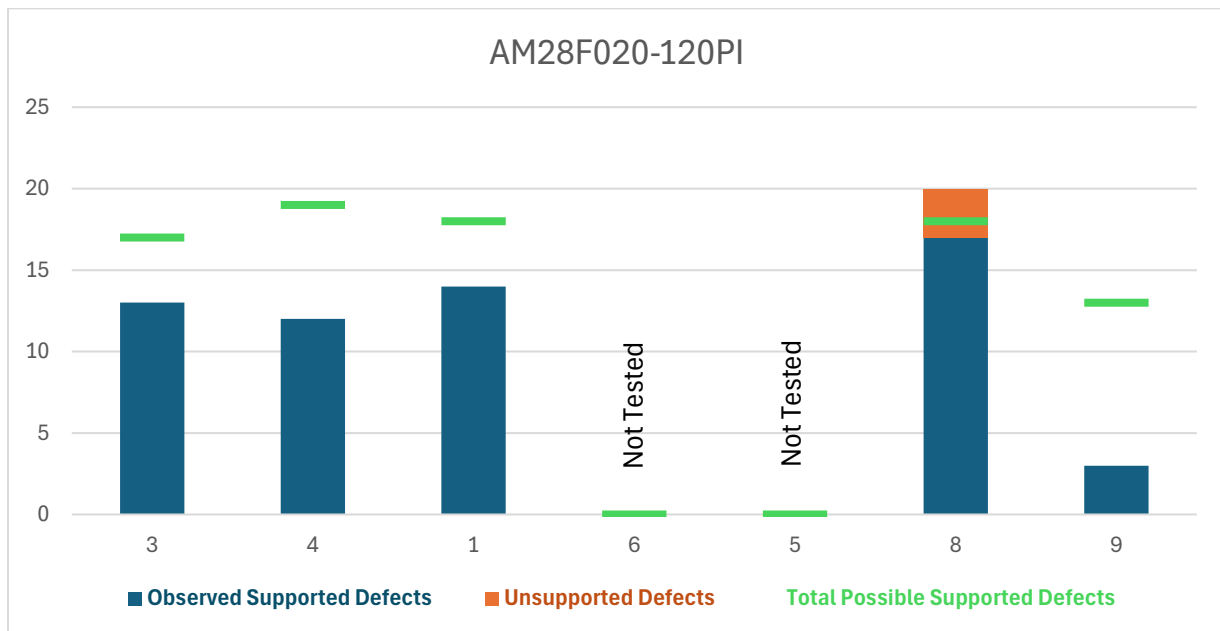
Figure 6 AM28F020-120PI Defect Detection

All labs identified this part as suspect counterfeit. Table 9 summarizes the test methods and specific defects which had high correlation (>60%) between the test labs. Table 10 lists the defects identified by each lab and whether there was strong evidence presented to validate the presence of this defect (by any lab). Strong evidence was used as a criteria for establishing the Consensus Conclusion for each part. This evidence also corresponds to defects which if present, should have been identifiable by test labs.

- Several instances of Intel die were found in inspected devices. Some indicated that this was not expected since AMD and Intel were competitors. However, during the time frame these devices were manufactured, second source agreements were used specifically for the Intel die. For example, the Catalyst Semiconductor CAT28F020 uses the Intel die in their equivalent part (<https://datasheet4u.com/pdf-down/C/A/T/CAT28F020-CatalystSemiconductor.pdf>). It is unclear if a second source agreement was also in place between AMD and Intel at this time. If AMD had a second source agreement with Intel for the use of Intel die in this device, finding Intel die would not be a sign of counterfeiting of this part. But the presence of mixed die and multiple die revisions within a single lot are positive indicators.

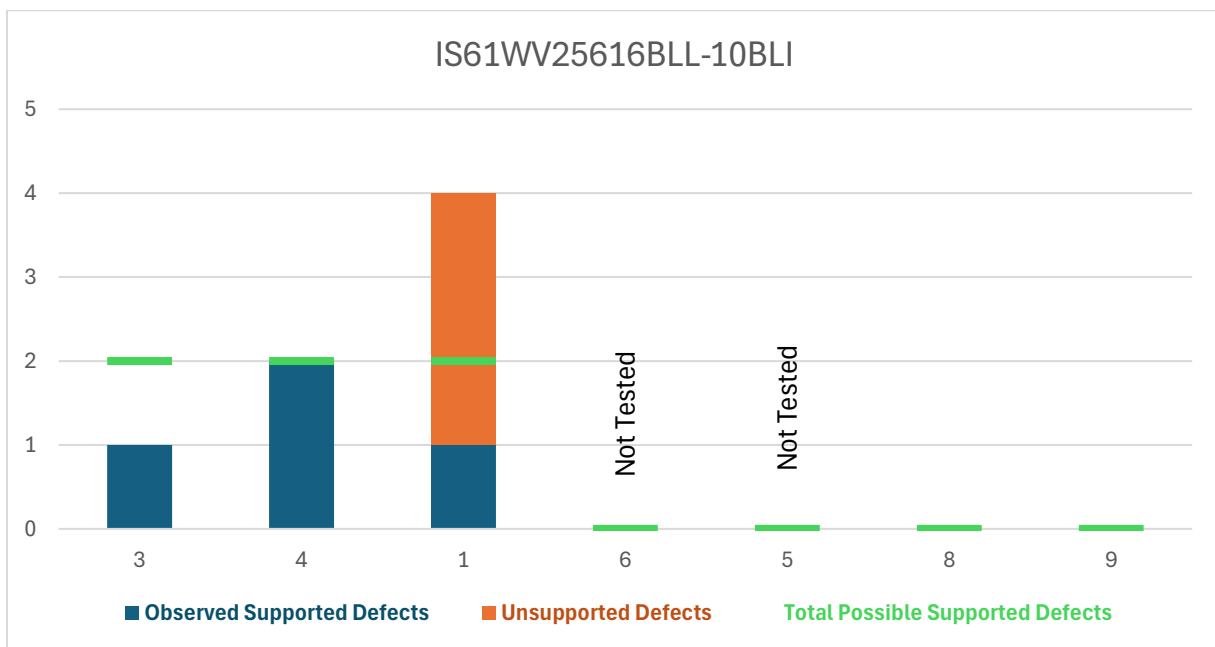
Figure 7 IS61WV25616BLL-10BLI Defect Detection

40% of the labs identified this part as suspect counterfeit. Table 11 summarizes the test methods and specific defects which had high correlation (>60%) between the test labs. Table 12 lists the defects identified by each lab and whether there was strong evidence presented to validate the presence of this defect (by any lab). Strong evidence was used as a criteria for establishing the Consensus Conclusion for each part. This evidence also corresponds to defects which if present, should have been identifiable by test labs. This part is a known authentic device. Aerocyonics purchased the part direct from Digi-Key who is an authorized distributor for ISSI (https://www.issi.com/WW/SalesNetwork/USSalesNetwork/Sales_Network.aspx?MID=Disti).

The parts were received in factory sealed packaging. Defects found with this part should have been attributed to quality issues as opposed to counterfeiting.

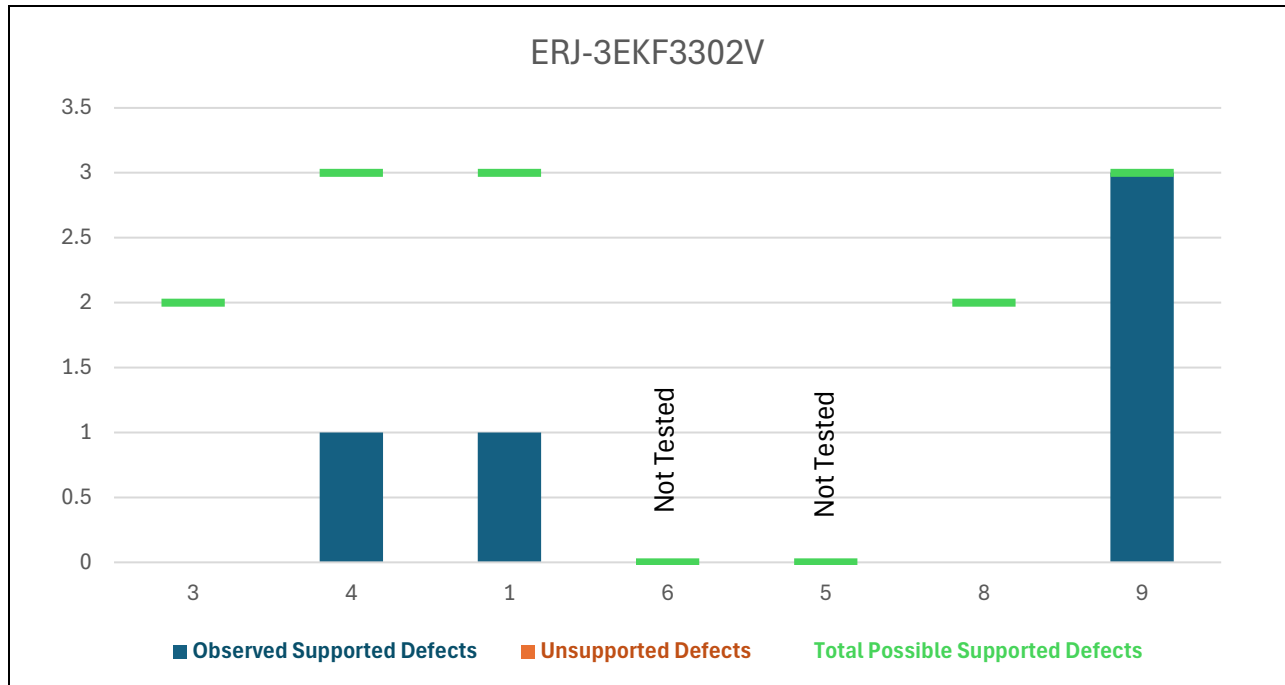
Figure 12 ERJ-3EKF3302V Defect Detection

ERJ-3EKF3302V – Suspect – These parts exhibited very few observable defects. However, two observations clearly support suspect counterfeit activity. The parts were marked with EEE on the top surface. This was confirmed by the manufacturer to be incorrect for this part. There should be no markings on this part. The end metal was also formed incorrectly. The metallization on the top surface should have defined notches on each side. The bottom surface should have continuous metal from side to side with no notches per the manufacturer's part drawing. This part had notches on both the top and bottom metal. Another attribute which was a clear indicator was the dimensional characteristics of the end metal. The manufacturer is very specific about the distance the metal encroaches into the center of the part. Many of these parts appear visually to exceed this specification, but unfortunately, none of the test labs verified this characteristic during their dimensional analysis.

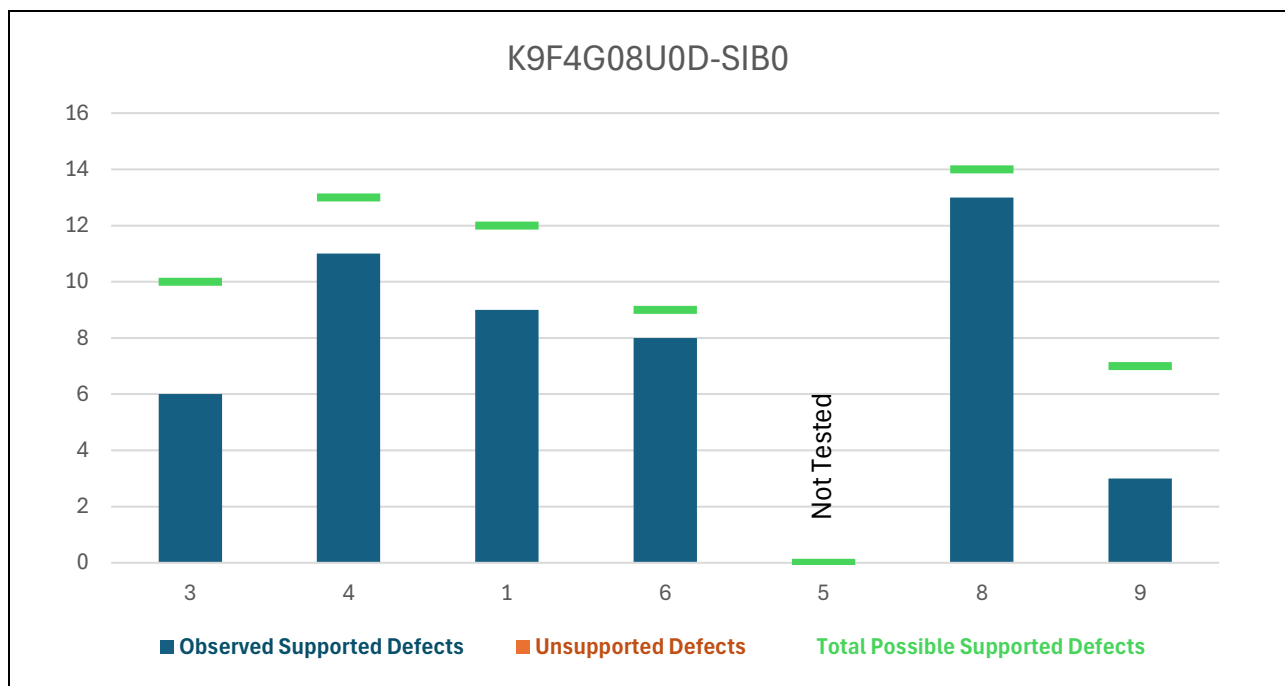
Figure 13 K9F4G08U0D-SIB0 Defect Detection

K9F4G08U0D-SIB0 – Suspect – The presence of sanding marks and blacktopping were clear evidence of suspect counterfeit activity. Ghost markings were present which further supports the surface alteration evidence. Device leads had clear indicators of refurbishment and were in poor condition. Attributes included bent leads, lack of tooling marks, plating thickness variation, and oxidation. These conditions further support the suspect counterfeit disposition.

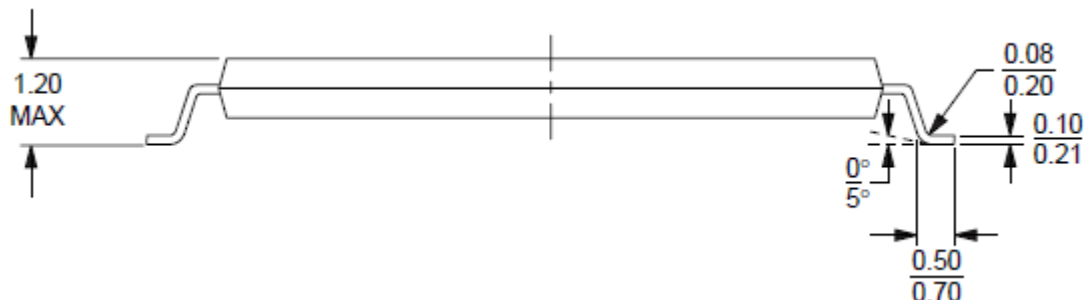
Figure 33 Typical Dimensional Drawing (AM28F020-120PI example)

- The dimensions test (AS6171/2A, section 5.3.5) states “nondestructively measure the overall part dimensions of body length, width, and thickness.” This requirement leads to interpretive issues.

- Part dimensional specifications nearly always include body length and width specifications with a specified acceptable range. Thickness requirements vary substantially. Within the part types included in the round robin, there were requirements for part body thickness, part total height (body thickness + lead/ball standoff), and maximum limits only, depending on the part type. Labs took varied approaches to comply with the test requirements. In one case, a derived requirement was established based on part total height. This resulted in out of specification results which did not actually violate any datasheet parameters. Other interpretations evaluated part total height instead of thickness. Others ignored thickness entirely, often substituting other measurements they considered significant. Better clarity on appropriate measurements should be provided, particularly regarding thickness measurements and/or appropriate substitution measurements. It is suggested that AS6171/2A be revised to state that length, width, and thickness be measured if explicitly quantified on the part dimensional drawing. If dimension requirements are not explicitly provided, then the closest “similar to” value should be used as an alternative measurement. As an example, referring to Figure 33, a common specified dimension is the part total height which in this drawing is 1.20mm maximum (no minimum requirement). Actual package thickness is not explicitly stated. The total height measurement would be used in place of measuring the part body thickness. For a second example, refer to Figure 4.

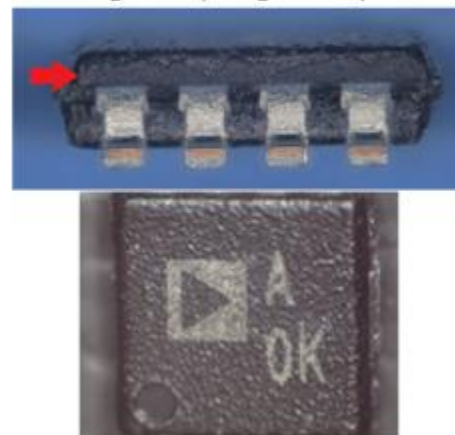
Comparison of the top surface of our parts with a known authentic part. Note the rougher texture on our part.

Edge and top images of our part.

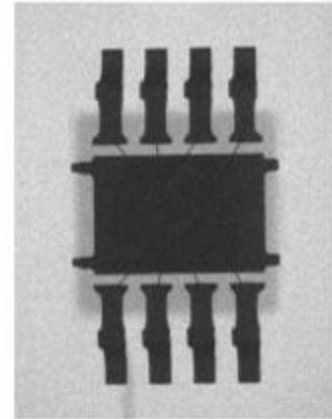
Presented hypothesis was that a surface coating was applied

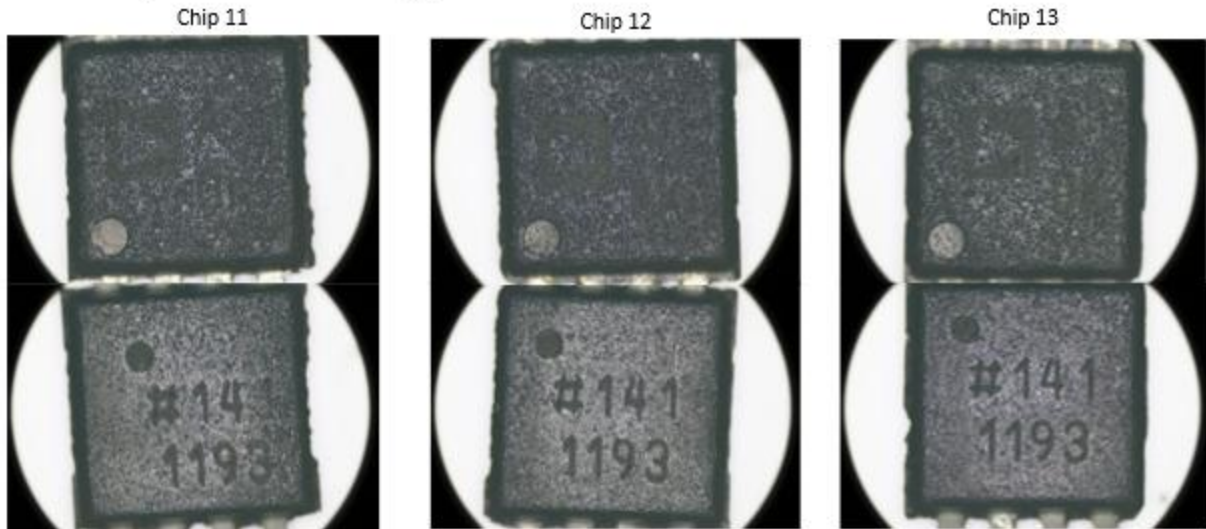
All samples appear qualitatively the same

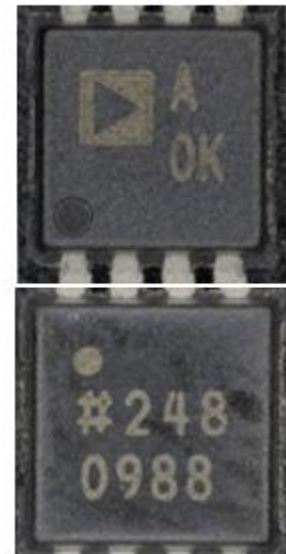
Chip 11

Results here are representative of all samples.
